**Flood Control Project Maintenance
Levee Inspections**

2019 Channel Summary Report

DWR Sutter Maintenance Yard

Big Chico Creek

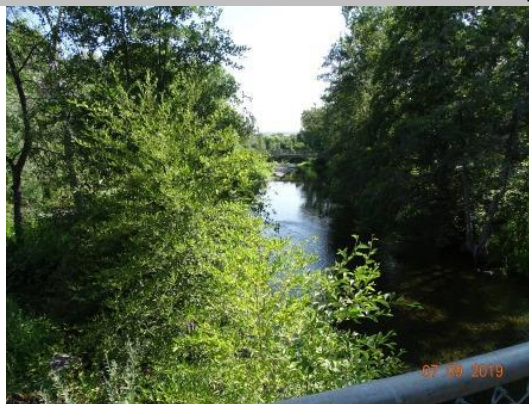
Photo 1 of 1 : CH_2019_NA0060_5_1_20190715_00030.jpg

Rating **	A	Issue No.	1	GPS Lat/Long
Issue Type +	Ma	Location *		39.761840 °
Category	Rivers, Channels & Designated Flood			-121.792590 °
Item	Vegetation & Obstructions			
DWR ID	DWR_NA0060_5_c_2012_1			
Action/Comments				
Inspector Comments: Minimal, scattered obstructions and vegetation. The flow is not impeded.

View of the channel from the structure facing upstream from the structure, 2019.

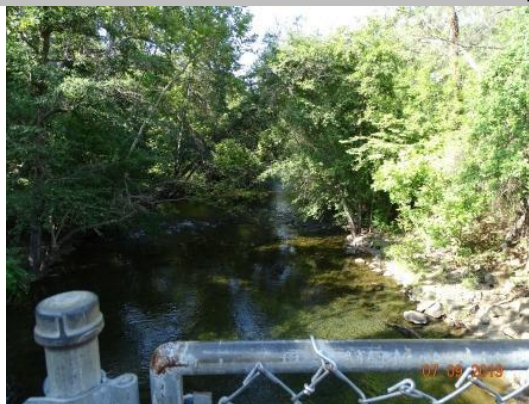
Photo 1 of 1 : CH_2019_NA0060_5_6_20190715_00033.jpg

View of the downstream side of the channel from the structure, 2019.

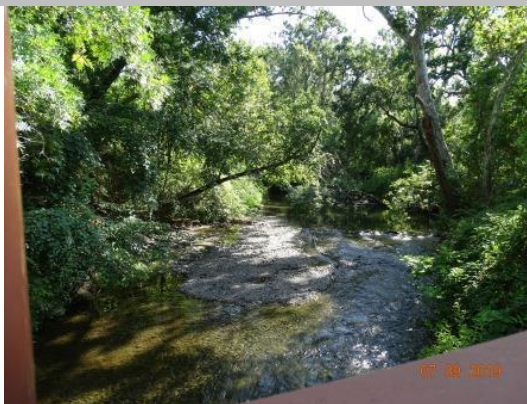
Photo 1 of 1 : CH_2019_NA0060_5_11_20190715_00034.jpg

This photo is looking upstream from under Manzanita Avenue Bridge, 2019.

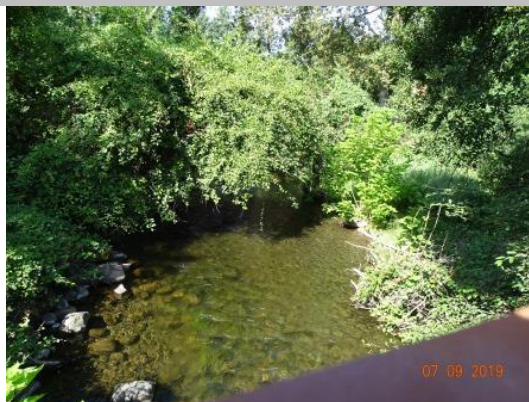
Photo 1 of 1 : CH_2019_NA0060_5_16_20190715_00037.jpg

This photo is looking downstream from Manzanita Avenue Bridge, 2019.

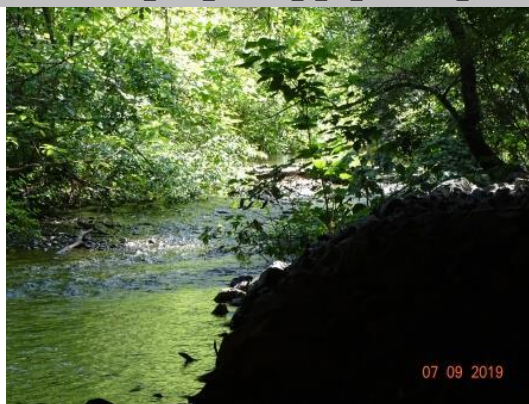
Photo 1 of 1 : CH_2019_NA0060_5_21_20190715_00038.jpg

View of the channel up from Highway 99 facing upstream, 2019.

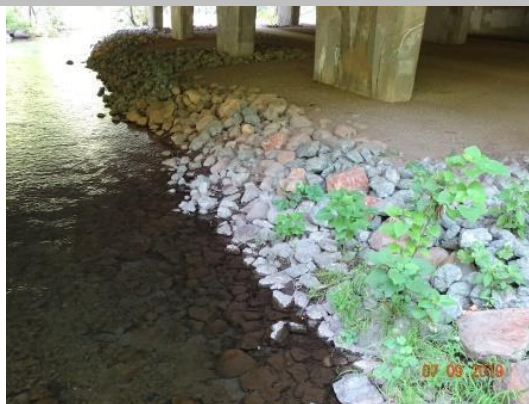
Photo 2 of 2 : CH_2019_NA0060_5_24_20190715_00039.jpg

View of revetment along the channel left bank, looking upstream, 2019.

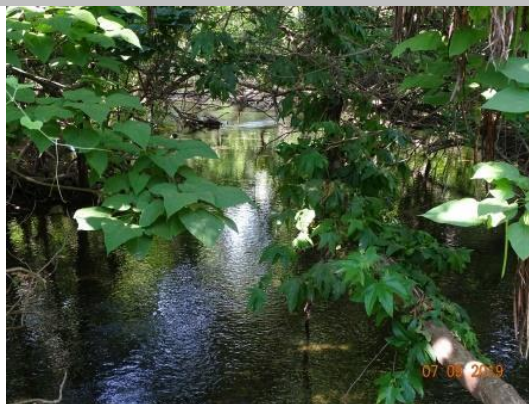
Photo 1 of 1 : CH_2019_NA0060_5_26_20190715_00041.jpg

View of the channel under Highway 99 facing downstream, 2019.

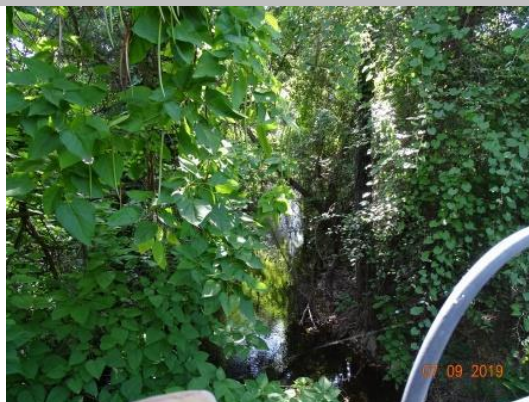
Photo 1 of 1 : CH_2019_NA0060_5_36_20190715_00045.jpg

View of the channel facing upstream, 2019.

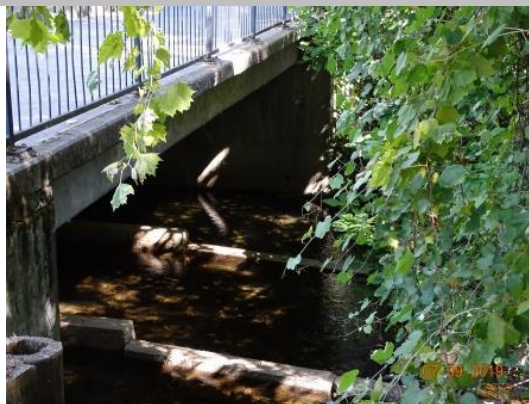
Photo 1 of 2 : CH_2019_NA0060_5_34_20190715_00046.jpg

No visible revetment right bank, 2019.

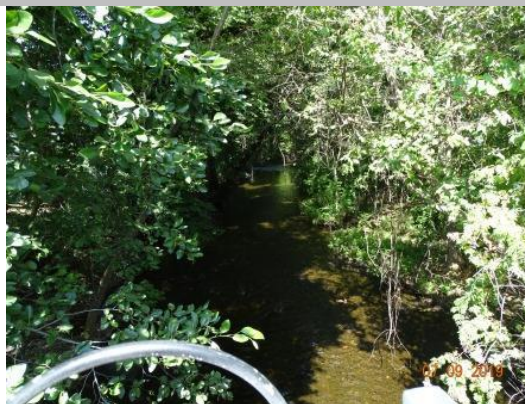
Photo 1 of 1 : CH_2019_NA0060_5_31_20190715_00044.jpg

View of the channel facing downstream, 2019.

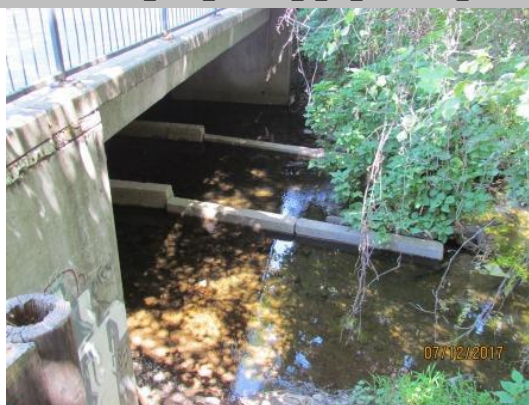
Photo 1 of 1 : CH_2019_NA0060_5_40_20190701_00020.jpg

View of old bridge footing in the channel.

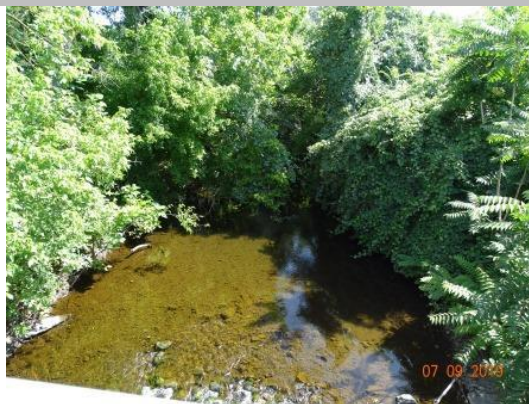
Photo 1 of 1 : CH_2019_NA0060_5_41_20190715_00048.jpg

View of the channel facing upstream, 2019.

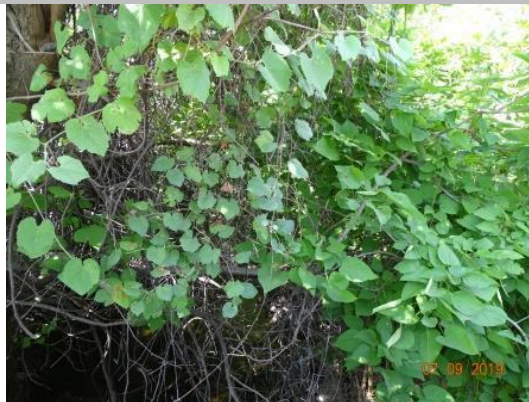
Photo 1 of 1 : CH_2019_NA0060_5_46_20190715_00051.jpg

View of the channel facing downstream, 2019.

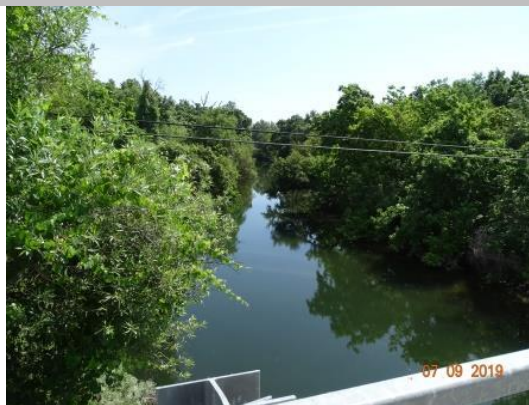
Photo 1 of 1 : CH_2019_NA0060_5_51_20190715_00052.jpg

View of Mud Creek at River Road facing upstream, 2019.

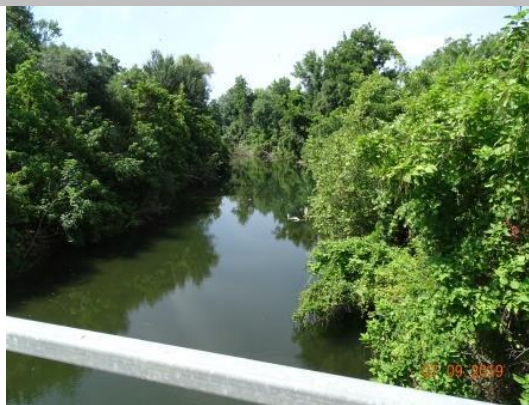
Photo 1 of 1 : CH_2019_NA0060_5_56_20190715_00053.jpg

Inspector Comments: No obstructions observed, the flow is not impeded.

View looking downstream from the bridge, 2019.

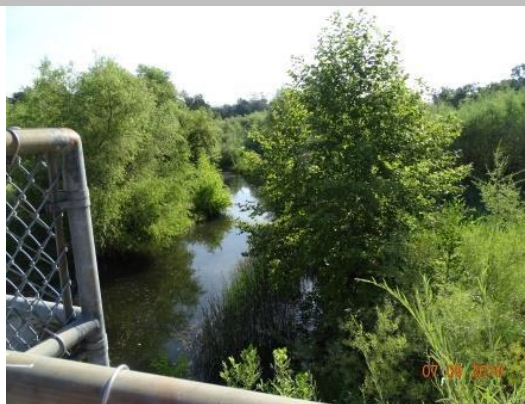
Photo 1 of 1 : CH_2019_NA0060_6_1_20190715_00063.jpg

View of the channel facing upstream, 2019.

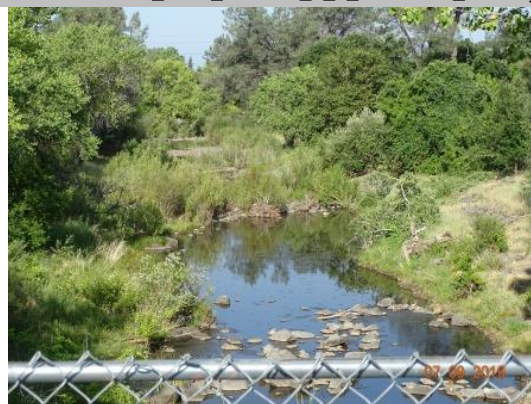
Photo 1 of 1 : CH_2019_NA0060_6_6_20190715_00064.jpg

View of the channel facing downstream, 2019.

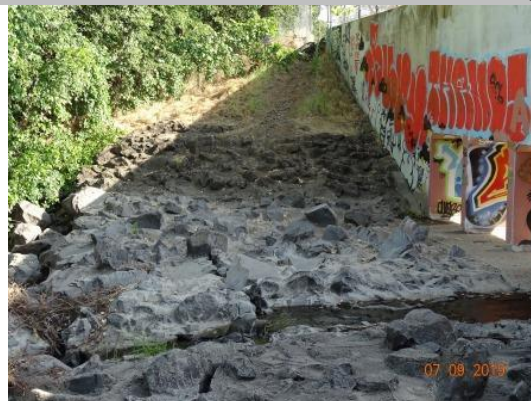
Photo 1 of 2 : CH_2019_NA0060_6_9_20190715_00065.jpg

Rating **	A	Issue No.	9	GPS Lat/Long
Issue Type +	Ma	Location *		39.761590 °
Category	Rivers, Channels & Designated Flood			-121.797320 °
Item	Revetments			
DWR ID	DWR_NA0060_6_c_2012_9			
Action/Comments				
Inspector Comments: Revetment observed at this location is intact, clearly visible, and well maintained.

View of revetment downstream of structure, right bank, 2019.

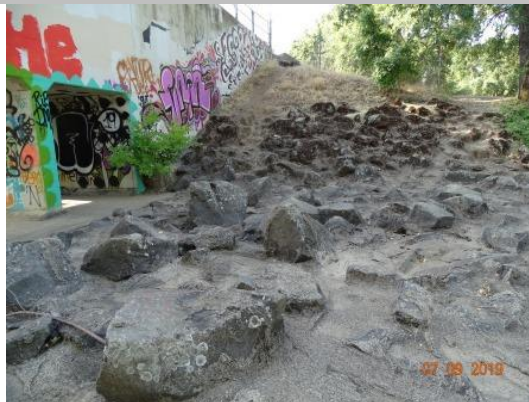
Photo 2 of 2 : CH_2019_NA0060_6_9_20190715_00066.jpg

Inspector Comments: Revetment observed at this location is intact, clearly visible, and well maintained.

View of revetment downstream of structure, left bank, 2019.

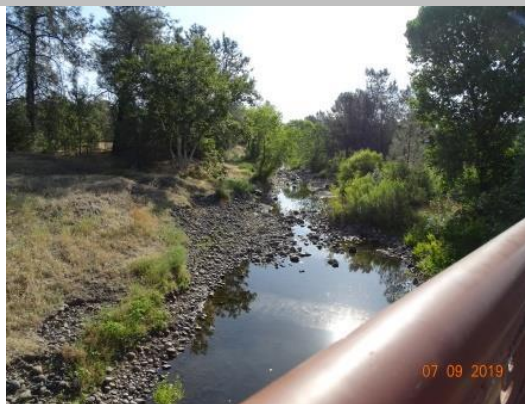
Photo 1 of 1 : CH_2019_NA0060_6_11_20190715_00067.jpg

View of the channel facing upstream, 2019.

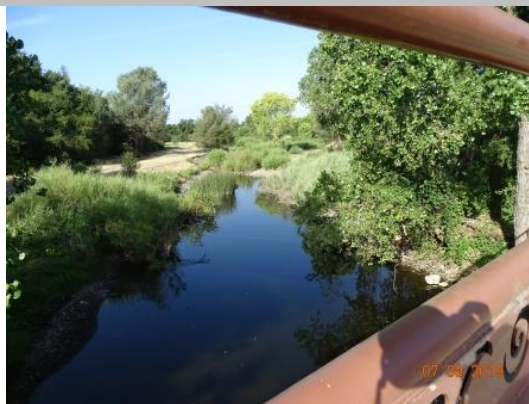
Photo 1 of 1 : CH_2019_NA0060_6_16_20190715_00068.jpg

View of the channel facing downstream, 2019.

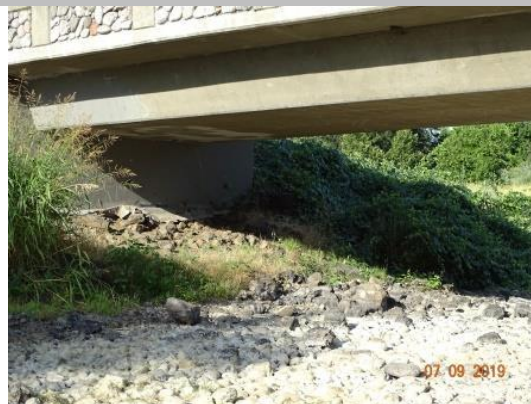
Photo 2 of 2 : CH_2019_NA0060_6_24_20190715_00072.jpg

View looking at the left bank abutment very little revetment remaining, 2019.

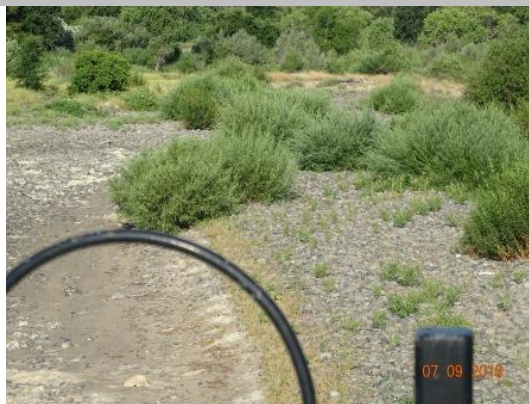
Photo 1 of 1 : CH_2019_NA0060_6_26_20190715_00074.jpg

View of the channel facing downstream from the bridge, 2019.

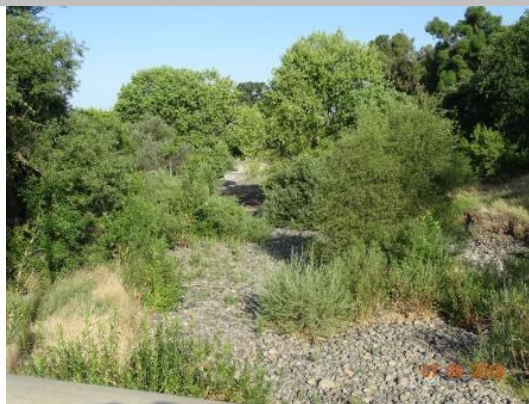
Photo 1 of 1 : CH_2019_NA0060_6_36_20190715_00078.jpg

View of the channel facing downstream from the bridge, 2019.

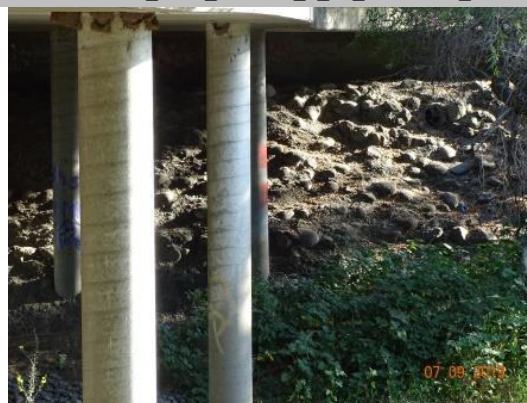
Photo 1 of 2 : CH_2019_NA0060_6_44_20190715_00082.jpg

View of right bank, revetment on slope up to the bridge abutment, 2019.

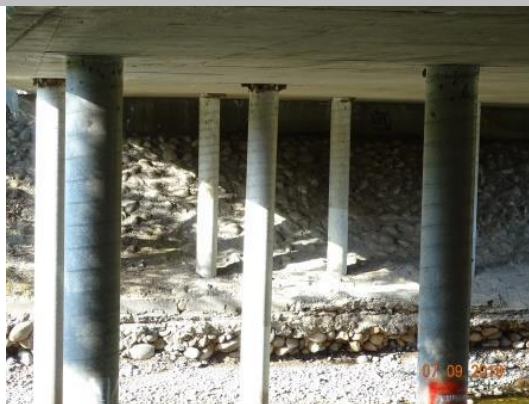
Photo 2 of 2 : CH_2019_NA0060_6_44_20190715_00083.jpg

View of left bank, revetment on slope up to the bridge abutment, 2019.

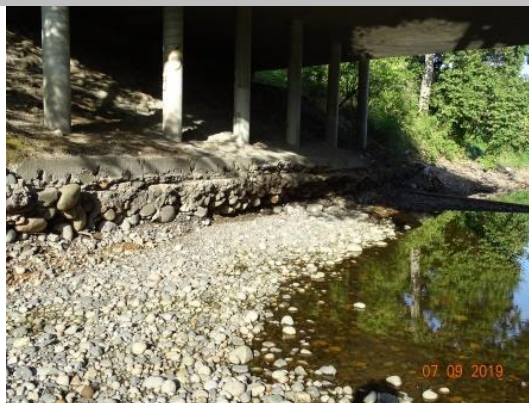
Photo 1 of 1 : CH_2019_NA0060_6_48_20190715_00081.jpg

View of the erosion found under the bridge south end left bank, 2019.

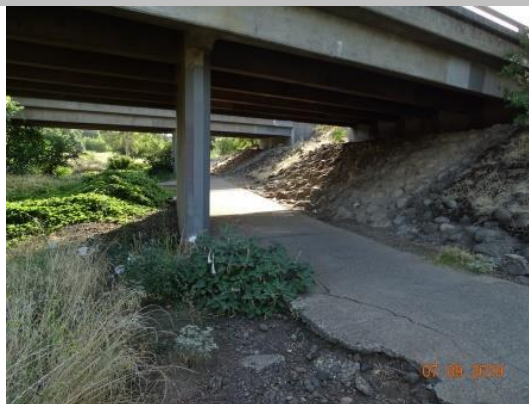
Photo 2 of 2 : CH_2019_NA0060_6_99_20190715_00087.jpg

View of left bank revetment looking upstream on slope up to the bridge abutment, 2019.

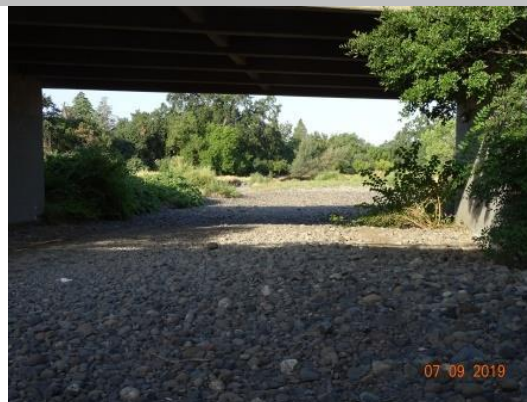
Photo 1 of 1 : CH_2019_NA0060_6_96_20190715_00088.jpg

View of the channel facing downstream from under the north bound lanes of Highway 99, 2019.

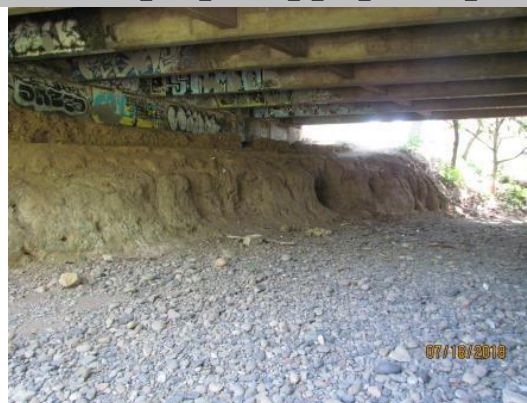
Photo 1 of 1 : CH_2019_NA0060_6_114_20190701_00058.jpg

View looking upstream at the right bank abutment, no revetment observed, 2018.

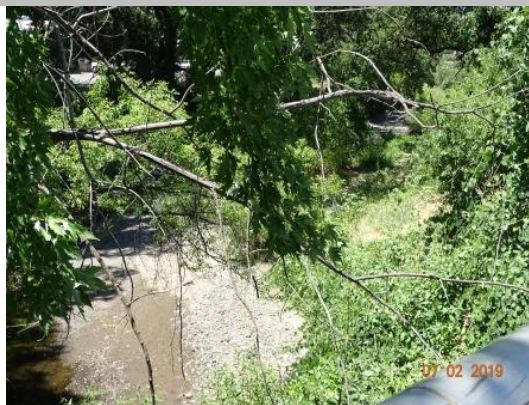
Photo 1 of 1 : CH_2019_NA0060_6_116_20190715_00091.jpg

View of the channel facing downstream, 2019.

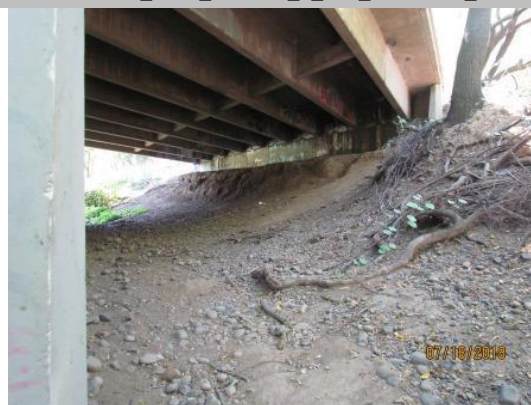
Photo 1 of 1 : CH_2019_NA0060_6_119_20190701_00061.jpg

View looking downstream at the right bank abutment, no revetment observed, 2018.

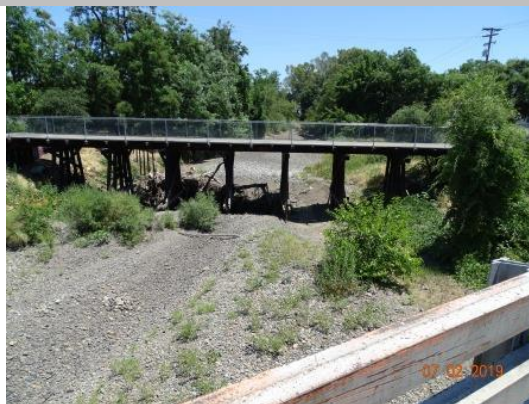
Photo 1 of 1 : CH_2019_NA0060_6_51_20190715_00094.jpg

View of the channel facing upstream, 2019.

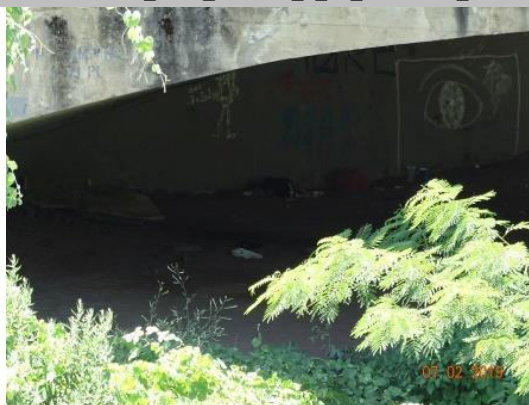
Photo 2 of 3 : CH_2019_NA0060_6_54_20190715_00096.jpg

View of the left abutment, no revetment exist, 2019.

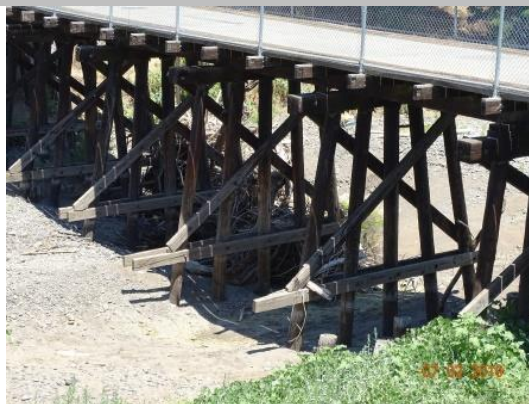
Photo 1 of 2 : CH_2019_NA0060_6_55_20190715_00093.jpg

View of the channel facing upstream. The debris is caught on the foot bridge piles, 2019.

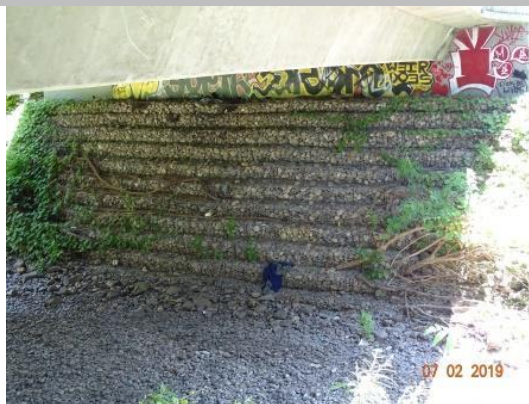
Photo 1 of 2 : CH_2019_NA0060_6_104_20190715_00101.jpg

View of gabion wall revetment at bridge abutment, left bank, 2019.

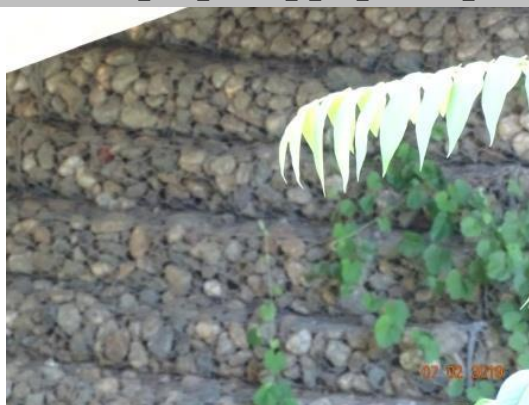
Photo 2 of 2 : CH_2019_NA0060_6_104_20190715_00100.jpg

View of gabion wall revetment at bridge abutment, right bank, 2019.

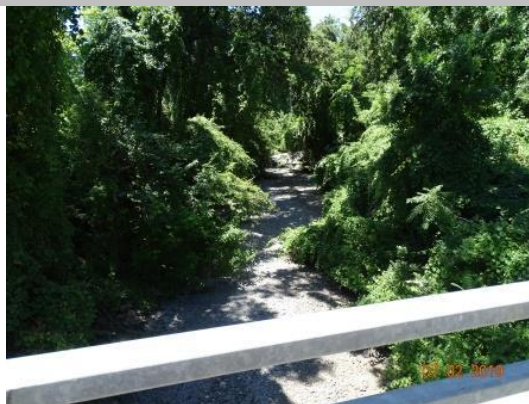
Photo 1 of 1 : CH_2019_NA0060_6_106_20190715_00102.jpg

View of the channel looking downstream, 2019.

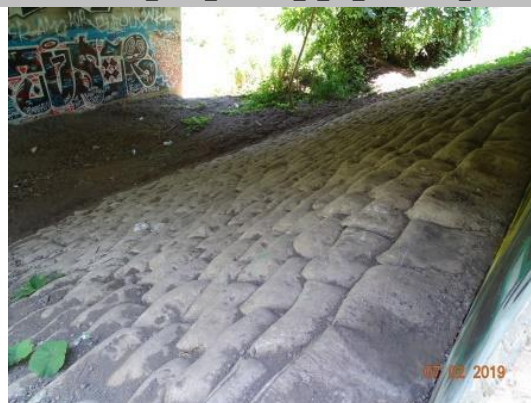
Photo 1 of 2 : CH_2019_NA0060_6_64_20190715_00105.jpg

View of right bank concrete filled sandbag revetment, typical for both sides, 2019.

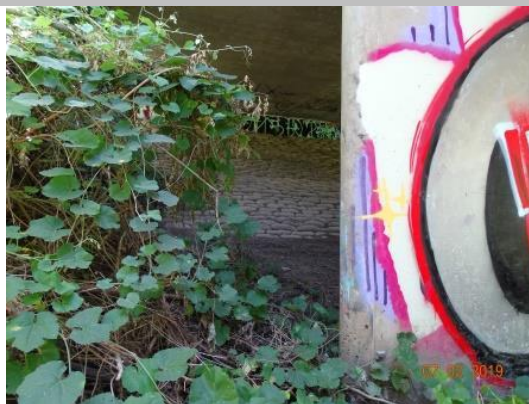
Photo 2 of 2 : CH_2019_NA0060_6_64_20190715_00104.jpg

View of left bank concrete filled sandbag revetment, typical for both sides, 2019.

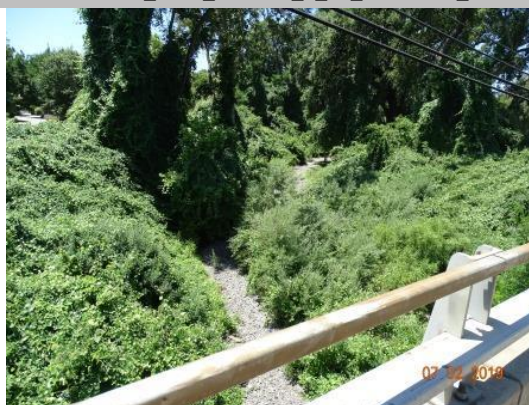
Photo 1 of 1 : CH_2019_NA0060_6_66_20190715_00106.jpg

View of the channel looking downstream, 2019.

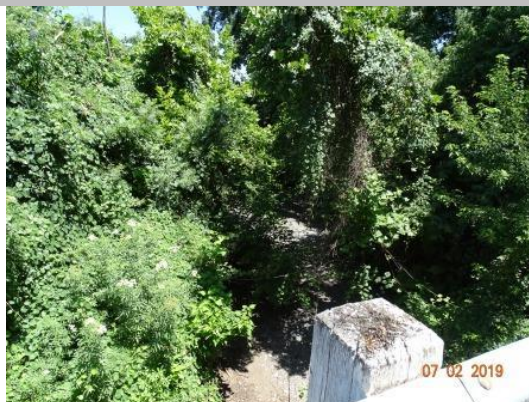
Photo 1 of 1 : CH_2019_NA0060_6_121_20190715_00107.jpg

View of the vegetation looking upstream from the bridge, 2019.

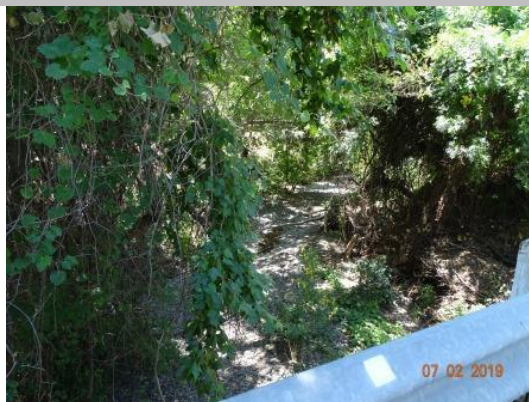
Photo 1 of 1 : CH_2019_NA0060_6_71_20190715_00111.jpg

View of the channel facing downstream, 2019.

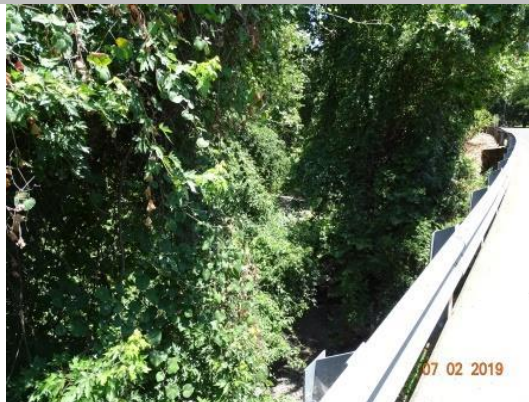
Photo 1 of 1 : CH_2019_NA0060_6_81_20190715_00112.jpg

View of the channel facing upstream, 2019.

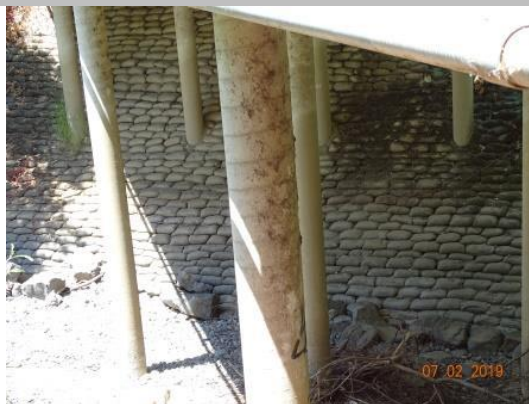
Photo 1 of 2 : CH_2019_NA0060_6_84_20190715_00115.jpg

View of concrete sandbag revetment at bridge abutments, right bank, 2019.

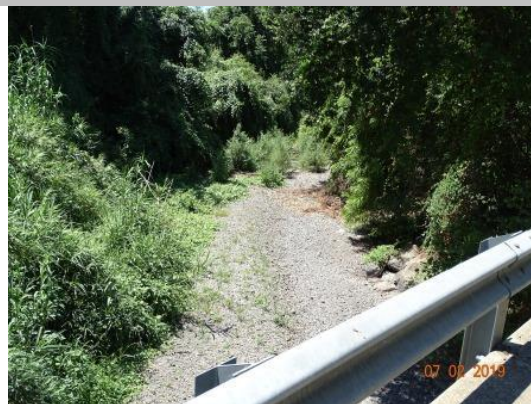
Photo 1 of 1 : CH_2019_NA0060_6_86_20190715_00113.jpg

View of the channel facing downstream, 2019.

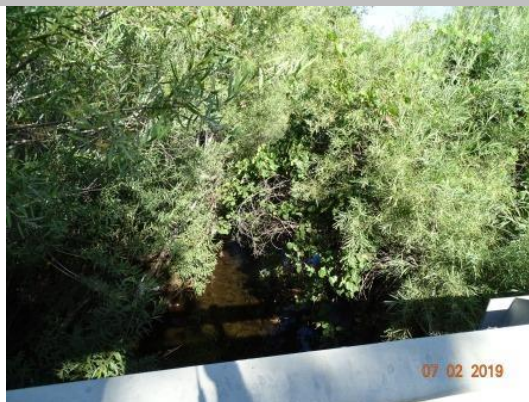
Photo 1 of 1 : CH_2019_NA0060_12_11_20190805_00093.jpg

View of the channel facing downstream, 2019.

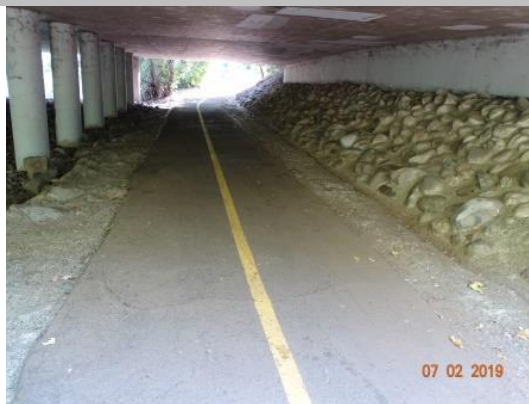
Photo 2 of 2 : CH_2019_NA0060_12_24_20190710_00053.jpg

View of revetment on left bank, 2019.

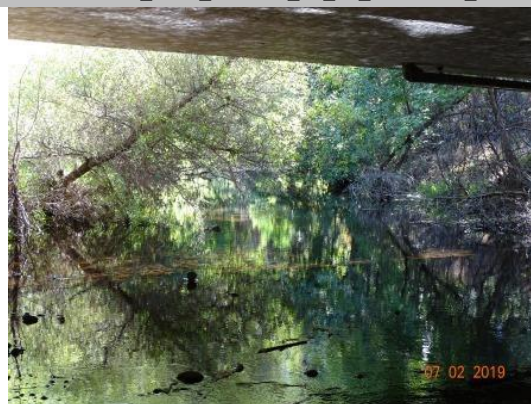
Photo 1 of 1 : CH_2019_NA0060_12_31_20190710_00055.jpg

View looking upstream from Hwy 99 bridge, 2019.

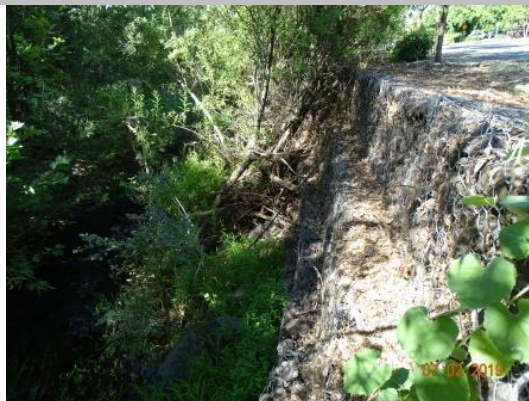
Photo 1 of 3 : CH_2019_NA0060_12_34_20190710_00056.jpg

View of the gabion wall repair 300 yards upstream of the bridge at Highway 99, 2019.

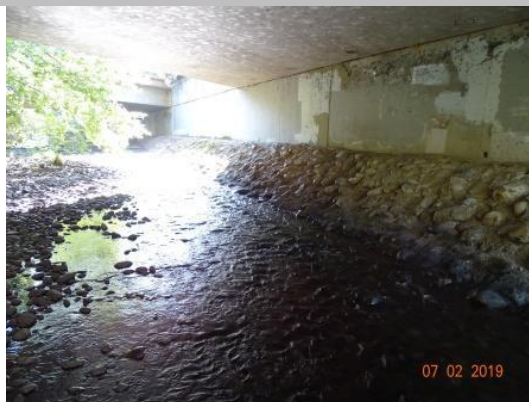
Photo 2 of 3 : CH_2019_NA0060_12_34_20190710_00057.jpg

View looking upstream of revetment at bridge abutment left bank, 2018.

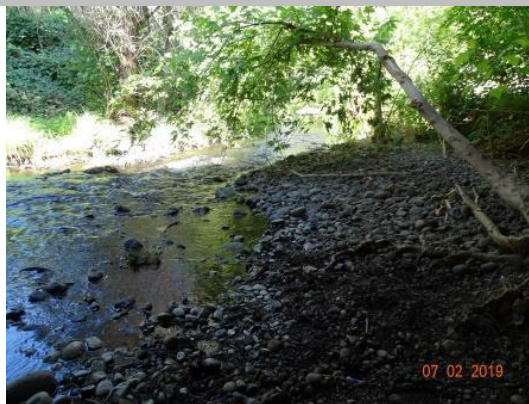
Photo 1 of 1 : CH_2019_NA0060_12_36_20190710_00059.jpg

View looking downstream from under the bridge, 2019.

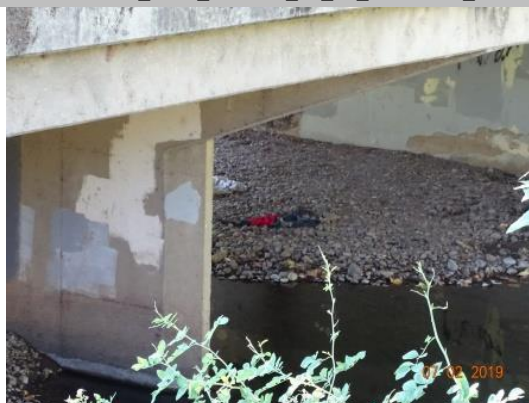
Photo 1 of 2 : CH_2019_NA0060_12_88_20190710_00062.jpg

View of the abutment right bank, no revetment was observed at either side, 2019.

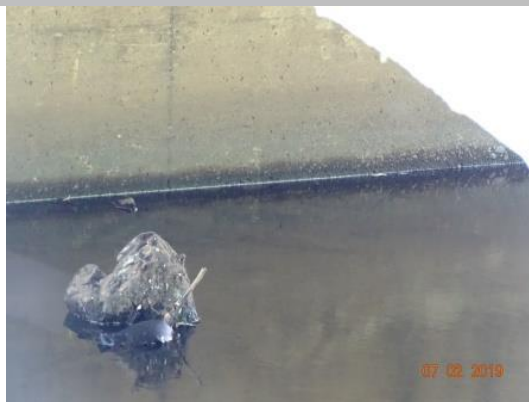
Photo 2 of 2 : CH_2019_NA0060_12_88_20190710_00063.jpg

View of the abutment left bank, no revetment was observed at either side, 2018.

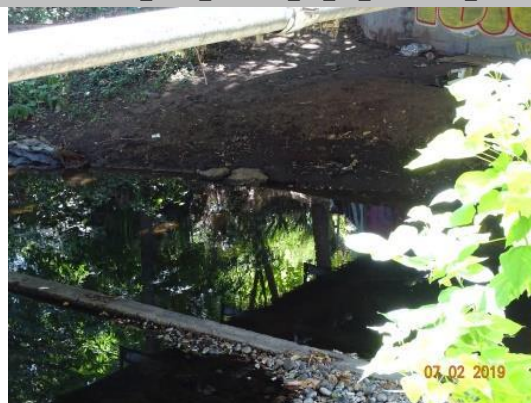
Photo 1 of 2 : CH_2019_NA0060_12_44_20190710_00065.jpg

View of the right bank abutment, no revetment present, 2019.

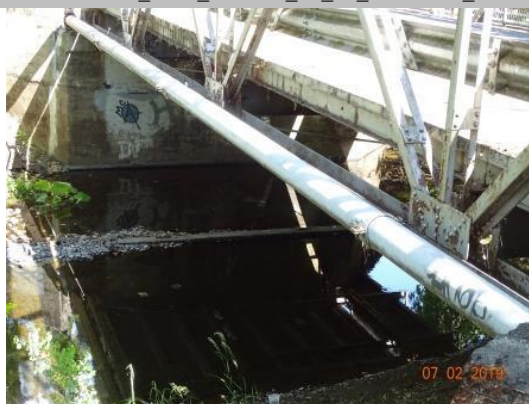
Photo 2 of 2 : CH_2019_NA0060_12_44_20190710_00066.jpg

View of the left bank abutment, no revetment present, 2019.

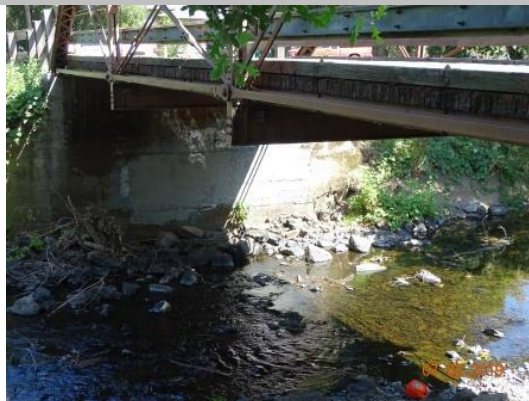
Photo 1 of 2 : CH_2019_NA0060_12_54_20190710_00069.jpg

View of the right abutment, no revetment present, 2019.

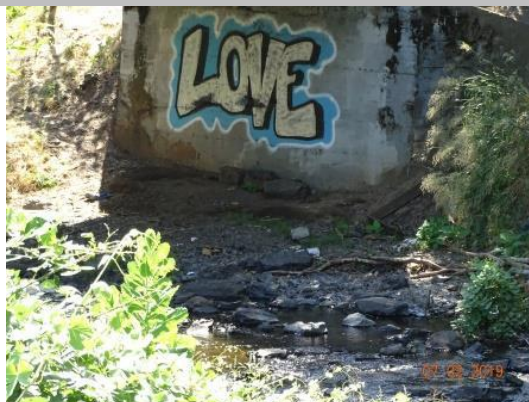
Photo 2 of 2 : CH_2019_NA0060_12_54_20190710_00070.jpg

View of the left abutment, no revetment present, 2019.

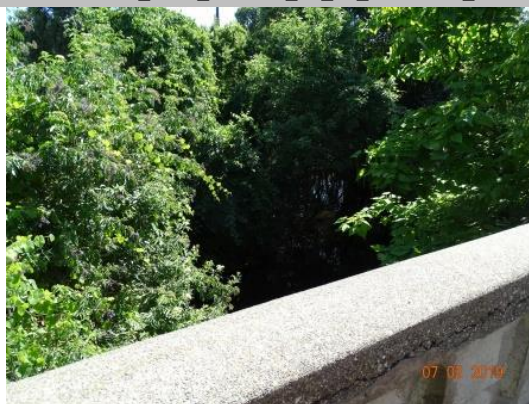
Photo 1 of 1 : CH_2019_NA0060_12_61_20190710_00072.jpg

View of the channel from the bridge facing upstream, 2019.

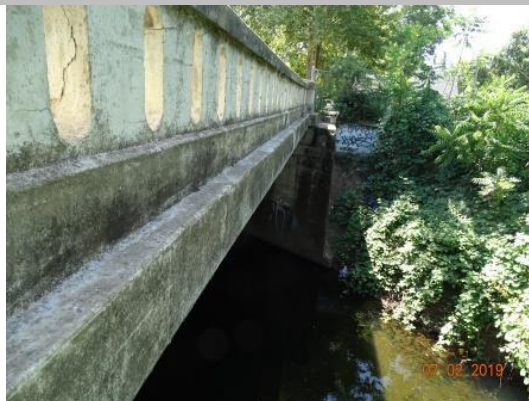
Photo 1 of 2 : CH_2019_NA0060_12_64_20190710_00073.jpg

View of left abutment, no revetment observed, 2019.

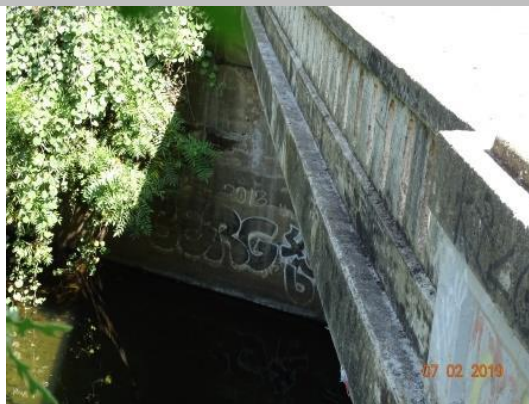
Photo 2 of 2 : CH_2019_NA0060_12_64_20190710_00074.jpg

View of right abutment, no revetment observed, 2019.

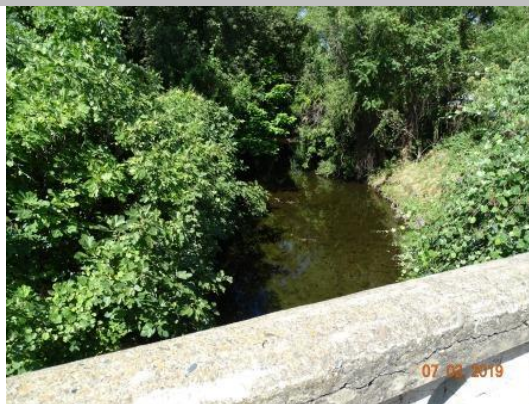
Photo 1 of 1 : CH_2019_NA0060_12_66_20190710_00075.jpg

View of the channel from the bridge facing downstream, 2019.

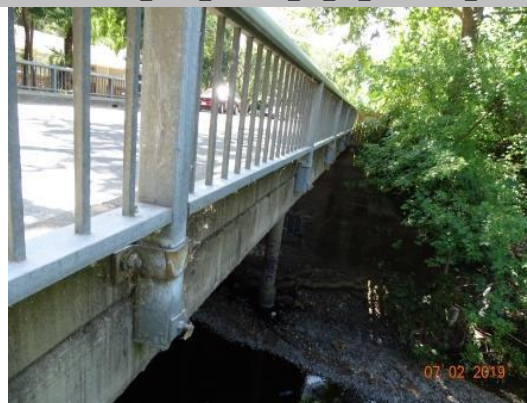
Photo 1 of 2 : CH_2019_NA0060_12_97_20190710_00080.jpg

No revetment observed on the left bank abutment, 2019.

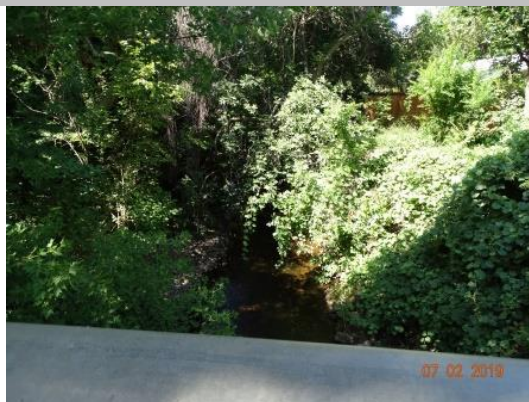
Photo 1 of 1 : CH_2019_NA0060_12_99_20190710_00082.jpg

View of the channel from the bridge facing downstream, 2019.

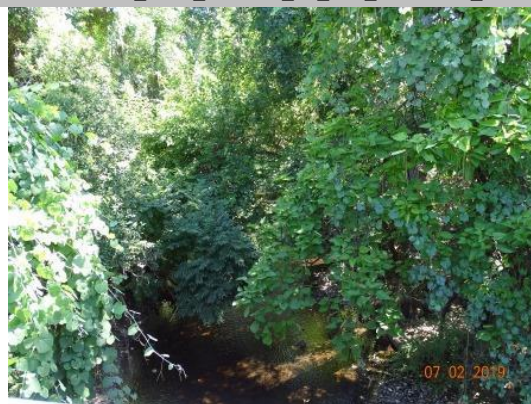
Photo 1 of 1 : CH_2019_NA0060_12_104_20190710_00083.jpg

View of the channel from the bridge facing upstream, 2019.

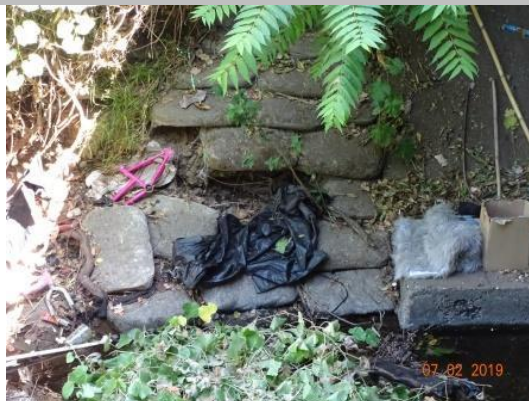
Photo 1 of 2 : CH_2019_NA0060_12_107_20190710_00085.jpg

View of the right bank abutment, revetment present, 2018.

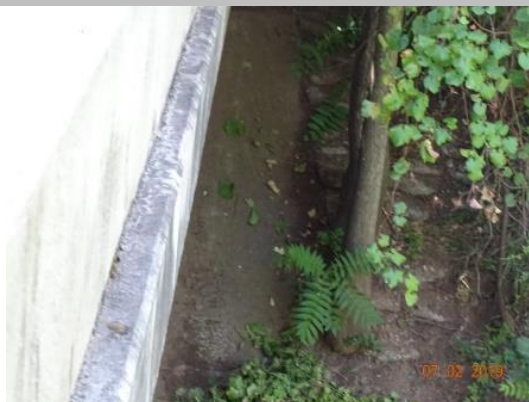
Photo 2 of 2 : CH_2019_NA0060_12_107_20190710_00084.jpg

View of the left bank abutment, no revetment present, 2019.

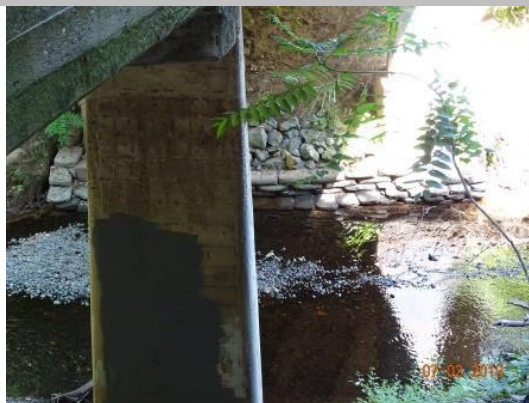
Photo 1 of 1 : CH_2019_NA0060_12_73_20190710_00089.jpg

View of erosion under the sandbag revetment, 2019.

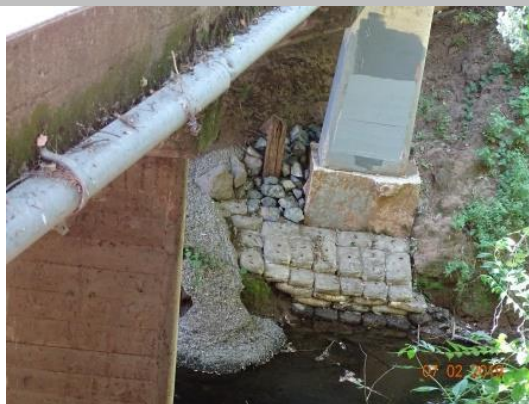
Photo 2 of 2 : CH_2019_NA0060_12_74_20190710_00091.jpg

View of concrete sandbag revetment on the channels edge right bank, 2019.

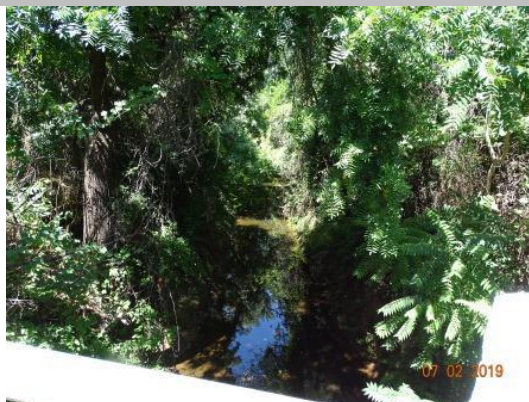
Photo 1 of 1 : CH_2019_NA0060_12_76_20190710_00092.jpg

View of the channel facing downstream from bridge, 2019.
